HUNTERS POINT SHIPYARD  
PARCEL E EMERGENCY REMOVAL ACTION  
LANDFILL GAS CONTROL SYSTEM

WEDNESDAY, 4 SEPTEMBER 2002  
DAILY ENGINEER'S REPORT

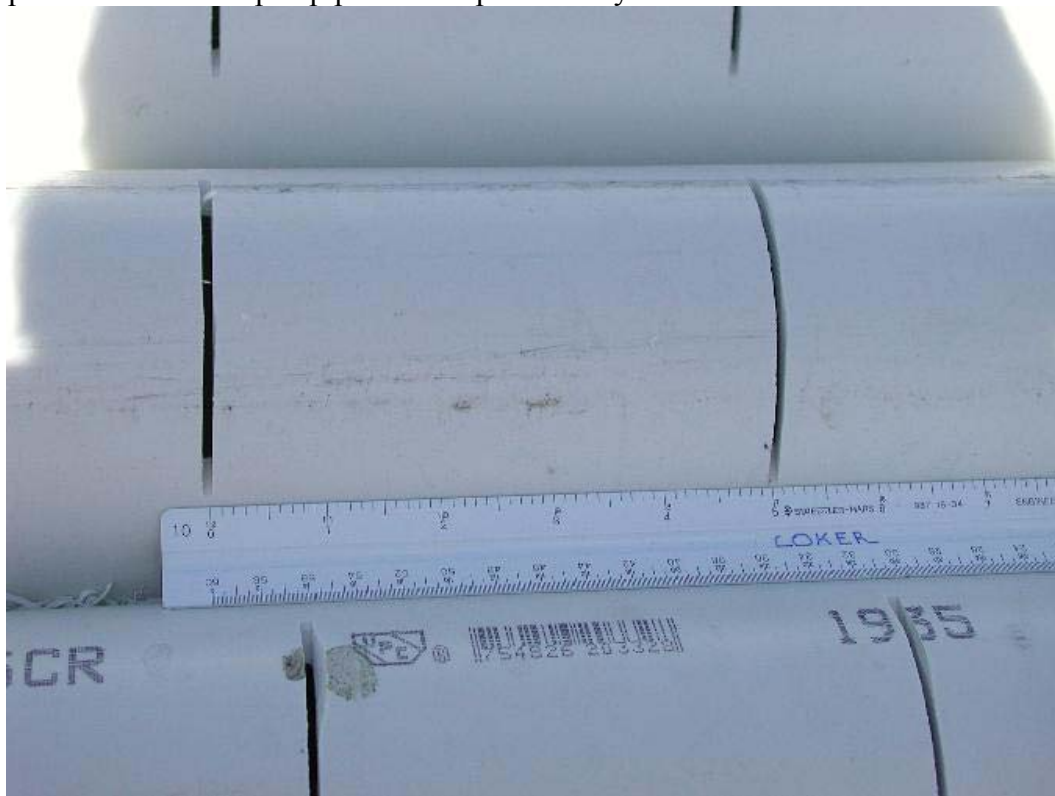
- Soil/debris excavated today is 260 cy with 55 cy stockpiled as suitable backfill.
- Demolished GMP 5.
- ITSI supervisor stated the gas collection pipe installation would **not begin** due to delay in geotextile delivery. See photographs for details regarding the field slotting of the pvc pipe by ITSI.

Photograph 1. Field slotted pvc pipe – slots spaced every 5-inches.

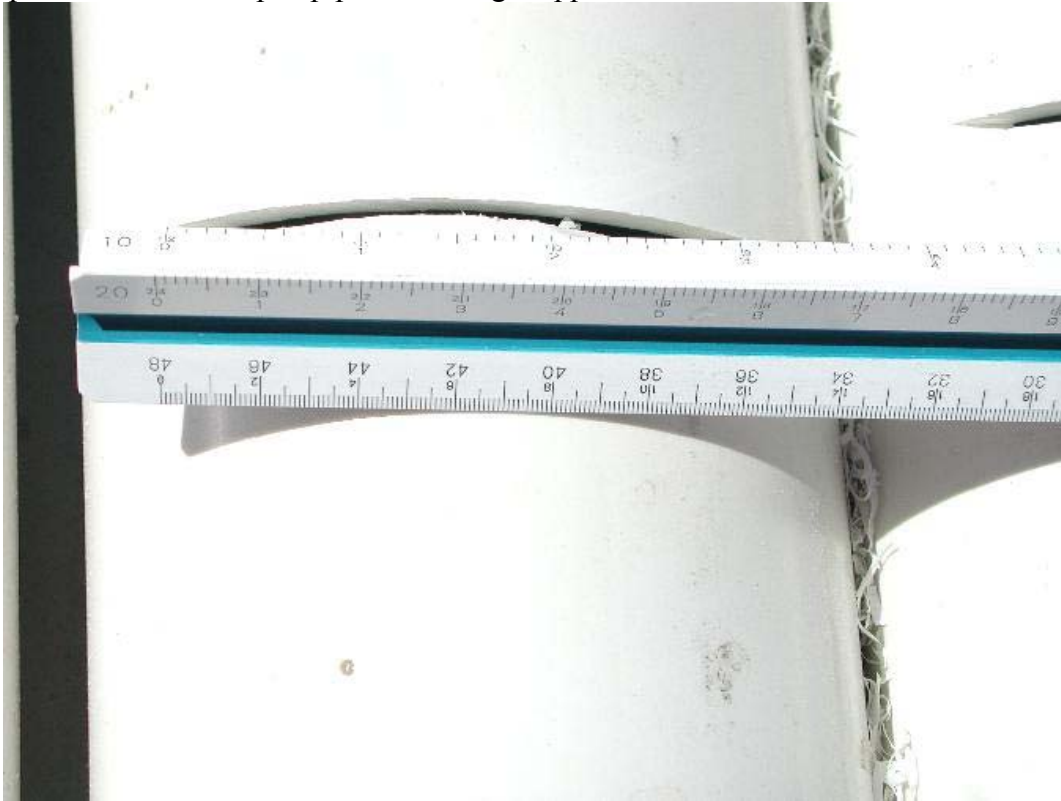
Photograph 2. Field slotted pvc pipe – slot length approx. 3-inches and 0.1-inch wide.

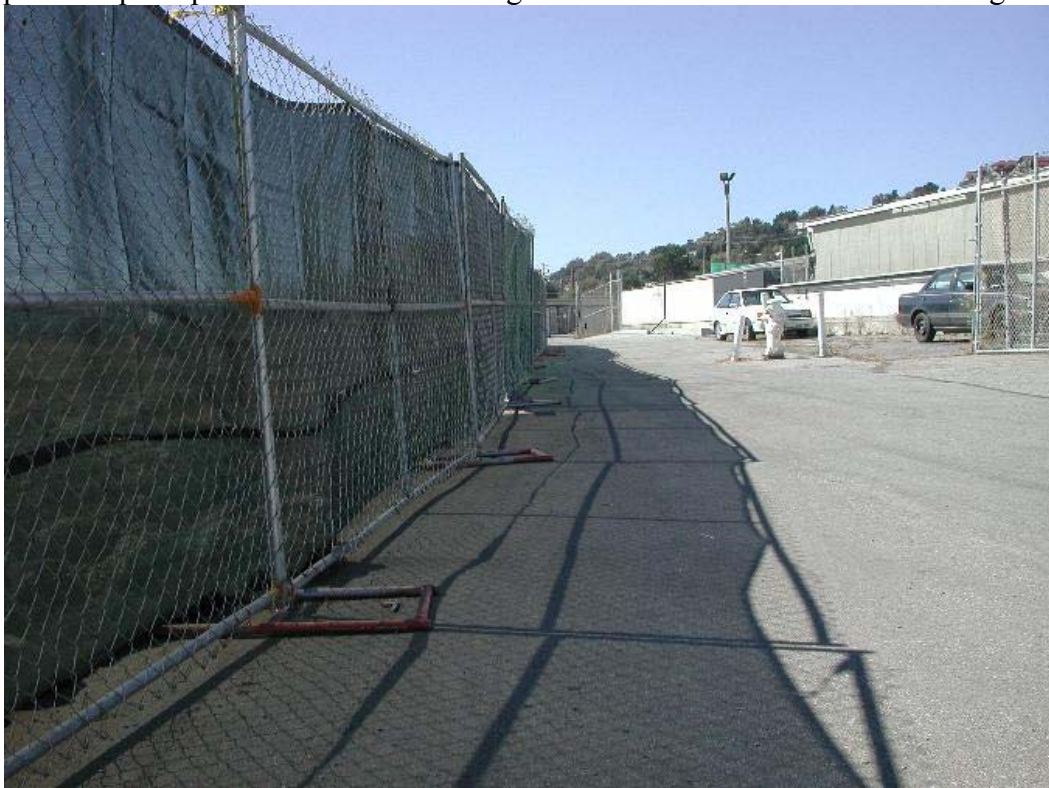
Photograph 3. Asphalt pavement on UCSF along excavated trench line – no visible signs damage.

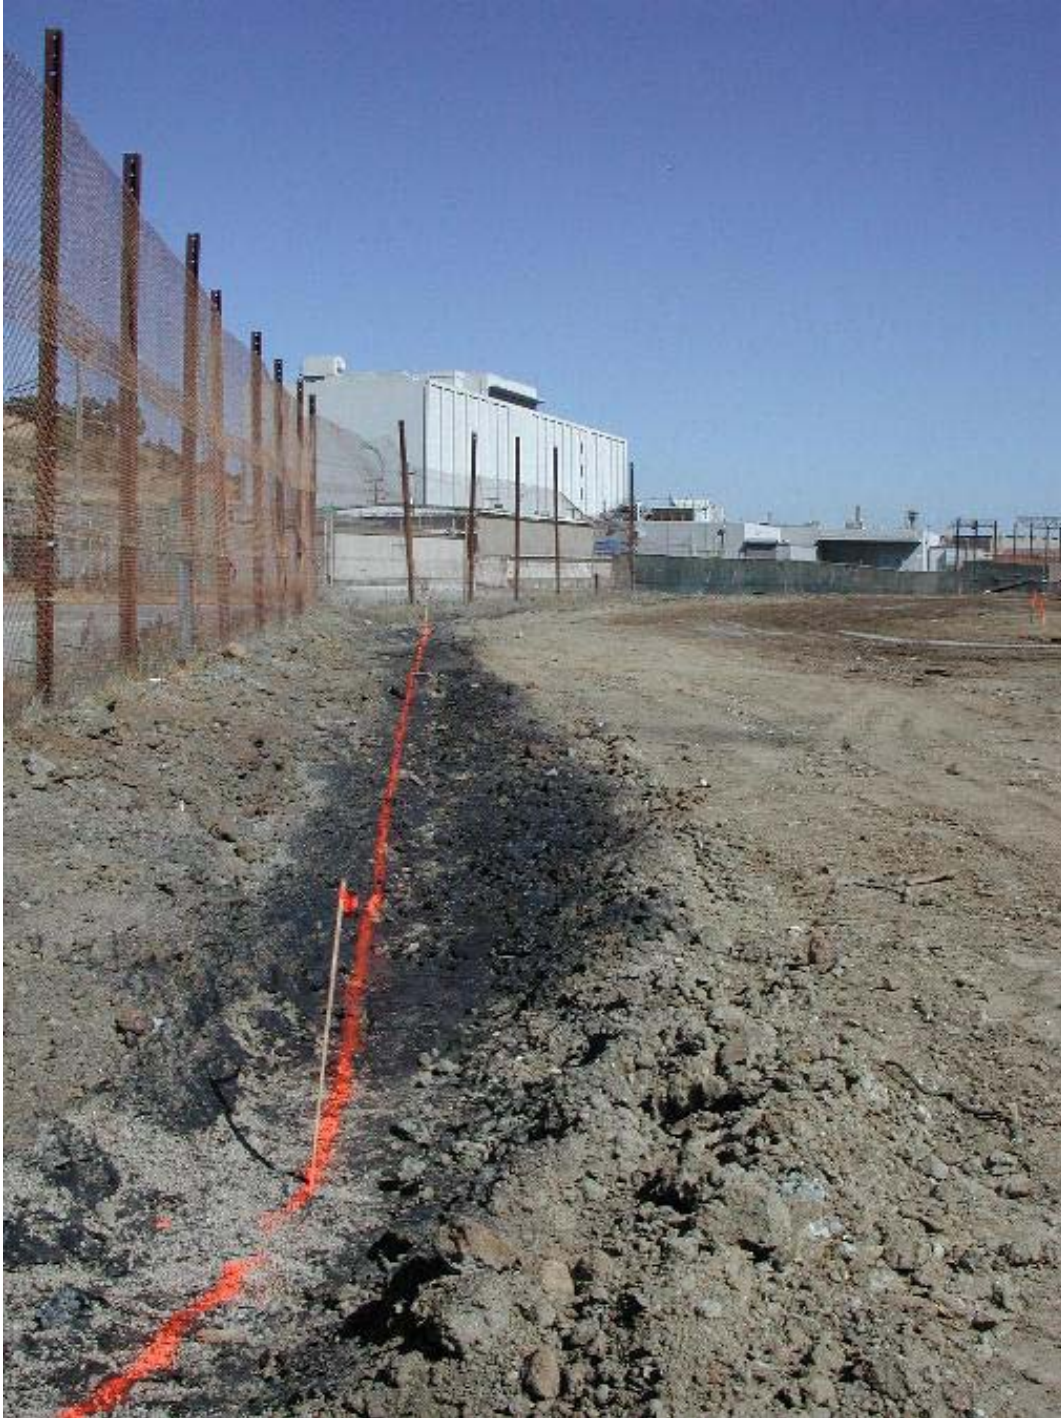
Photograph 4. Centerline of gravel backfilled trench with long term foam application. Looking from STA 12+00 towards STA 11+00.

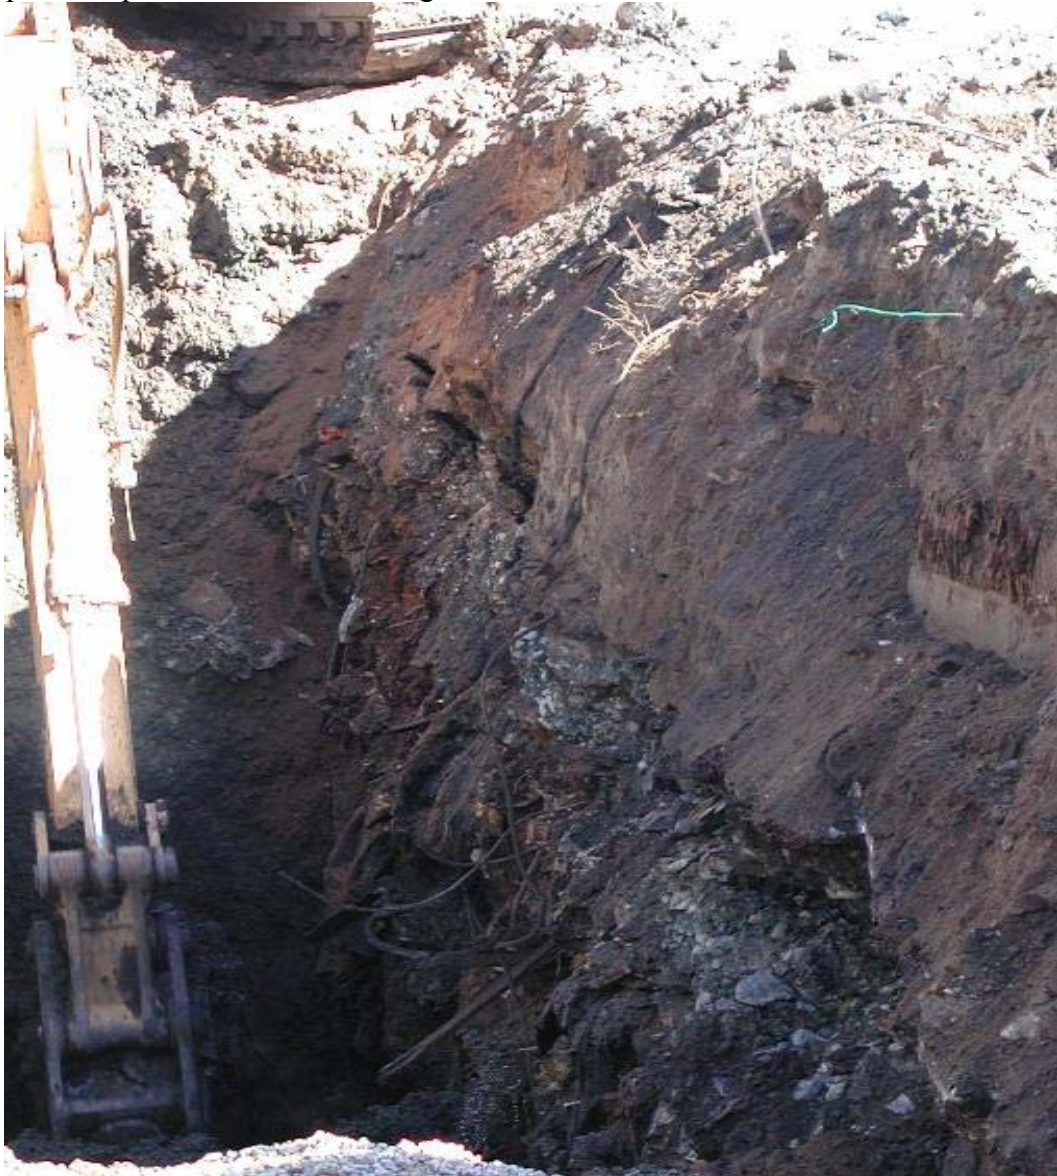
Photograph 5. Representative view of edge of industrial landfill waste.

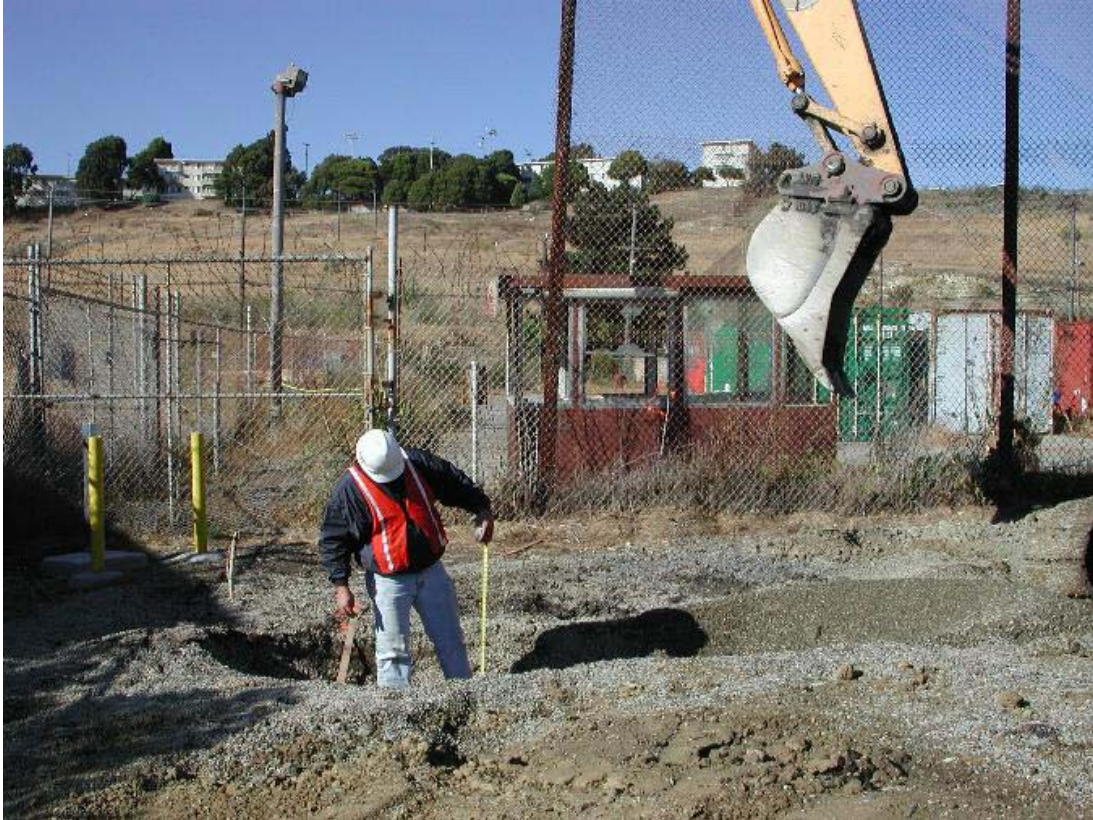
Photograph 6. Preparing gravel backfilled trench for pvc pipe installation.

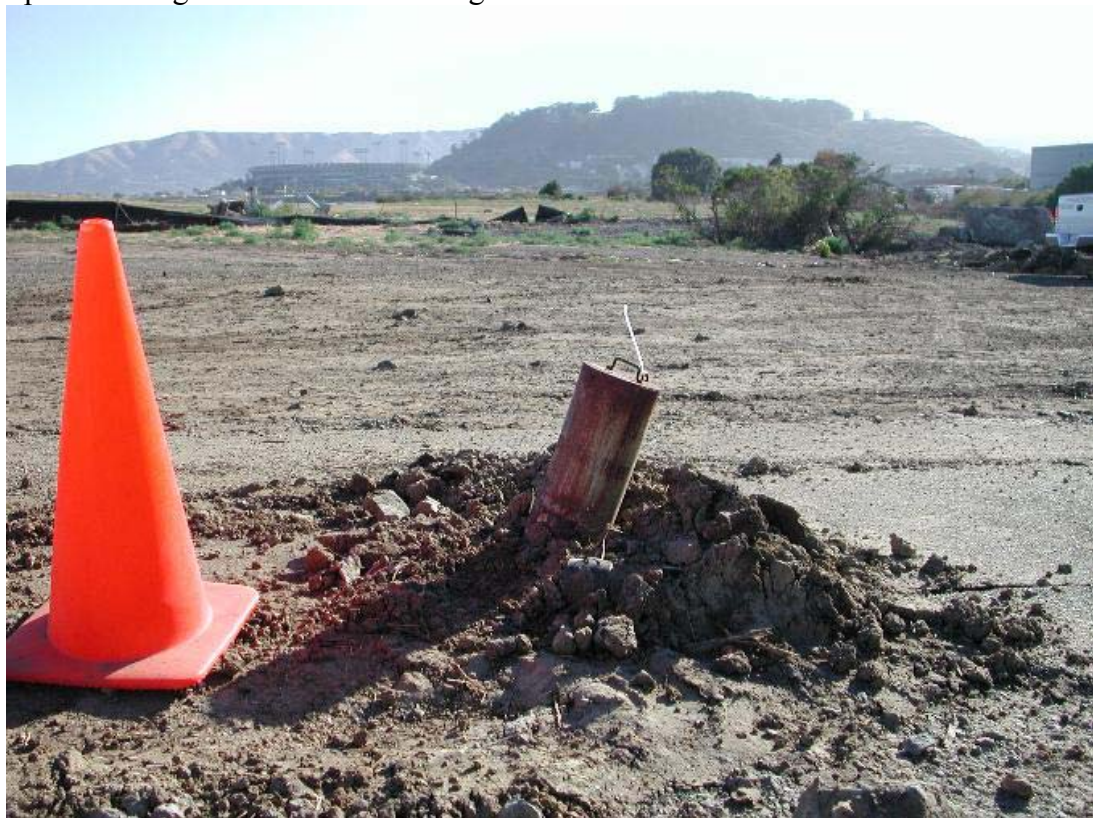
Photograph 7. Bent groundwater monitoring well labeled IR01P03A.

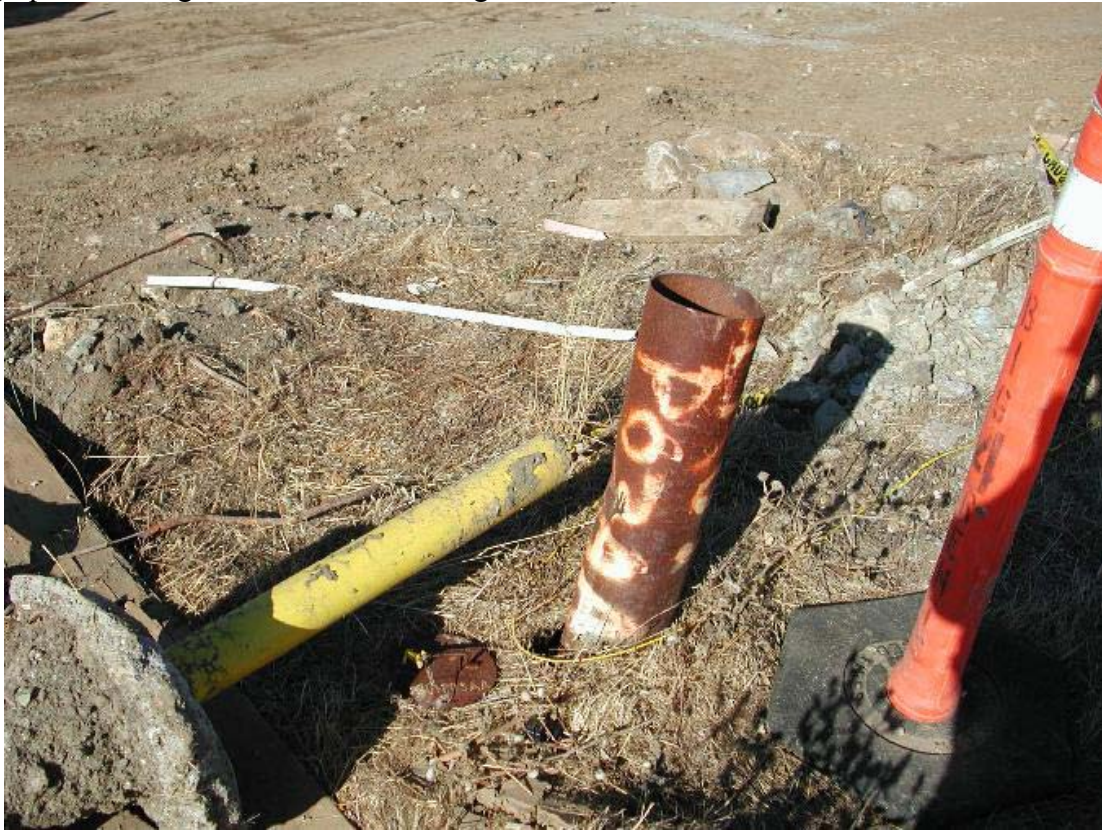
Photograph 8. Bent groundwater monitoring well IR01P03AA.
